**Technical Service
BULLETIN**

Title:
EXCESSIVE SULFUR DIOXIDE ODOR
Models:
'03 – '04 Matrix (1ZZ-FE)

ENGINE
EG017-04

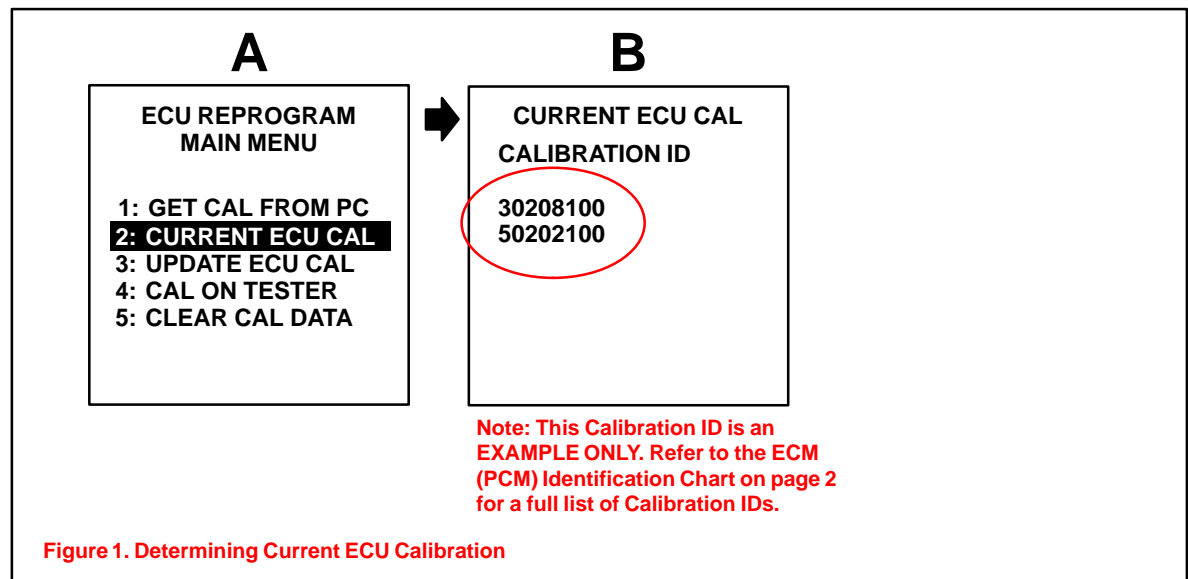
1. Check for the Authorized Modification Label affixed to the vehicle in the location shown in Figure 2 on page 5. If there is no label present, proceed to step 2.
2. Connect the Diagnostic Tester to the vehicle and select “CURRENT ECU CAL” from the “ECU REPROGRAM MAIN MENU.” To determine the vehicle’s current ECM calibration, see Figure 1 shown below.

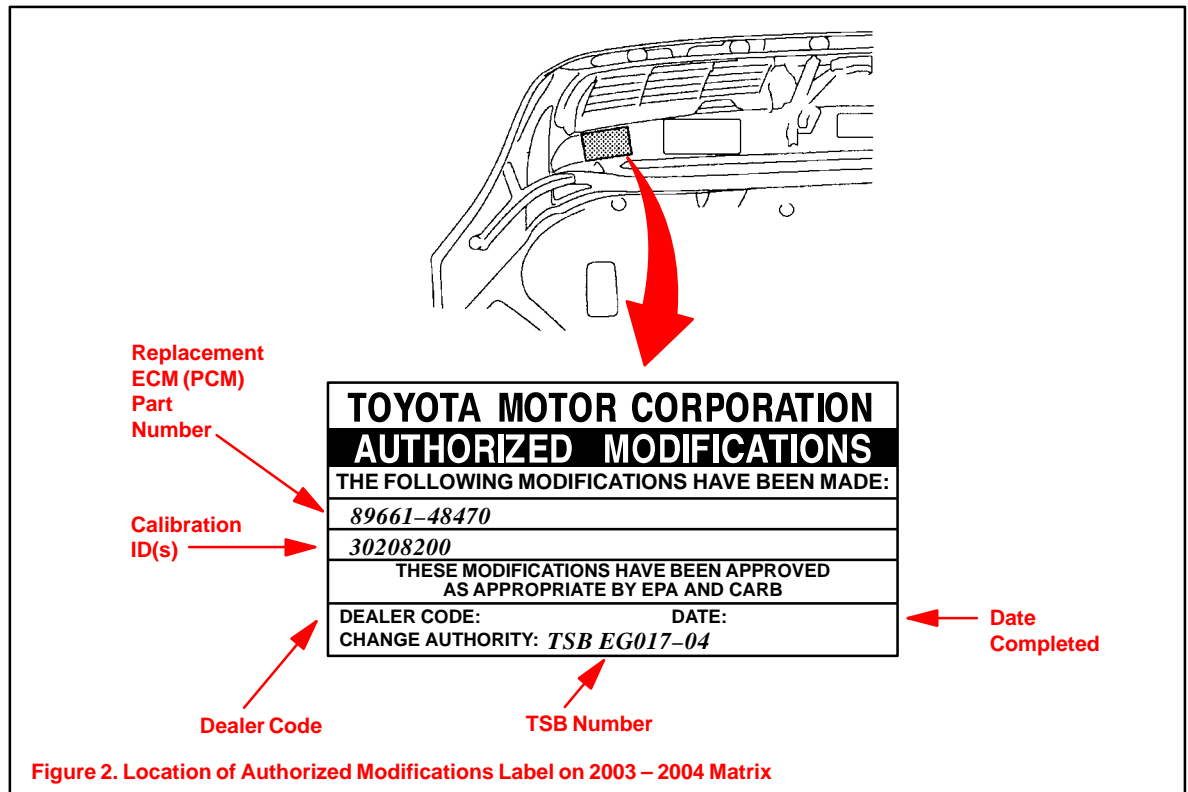
7. Enter the following information on the Authorized Modification Label shown below in Figure 2 using a permanent marker.
 - ECM (PCM) part number.
 - New ECM (PCM) calibration number.
 - Your dealer code.
 - Reprogramming date.
 - This TSB number.
